APPENDIX A

CULTURAL RESOURCE SURVEY FORMS

CULTURAL RESOURCE SURVEY
SURVEY UPDATE FORM

J. SPEAR FARMSTEAD, BLACKBIRD HUNDRED:
A DOCUMENTARY AND ARTIFACTUAL STUDY

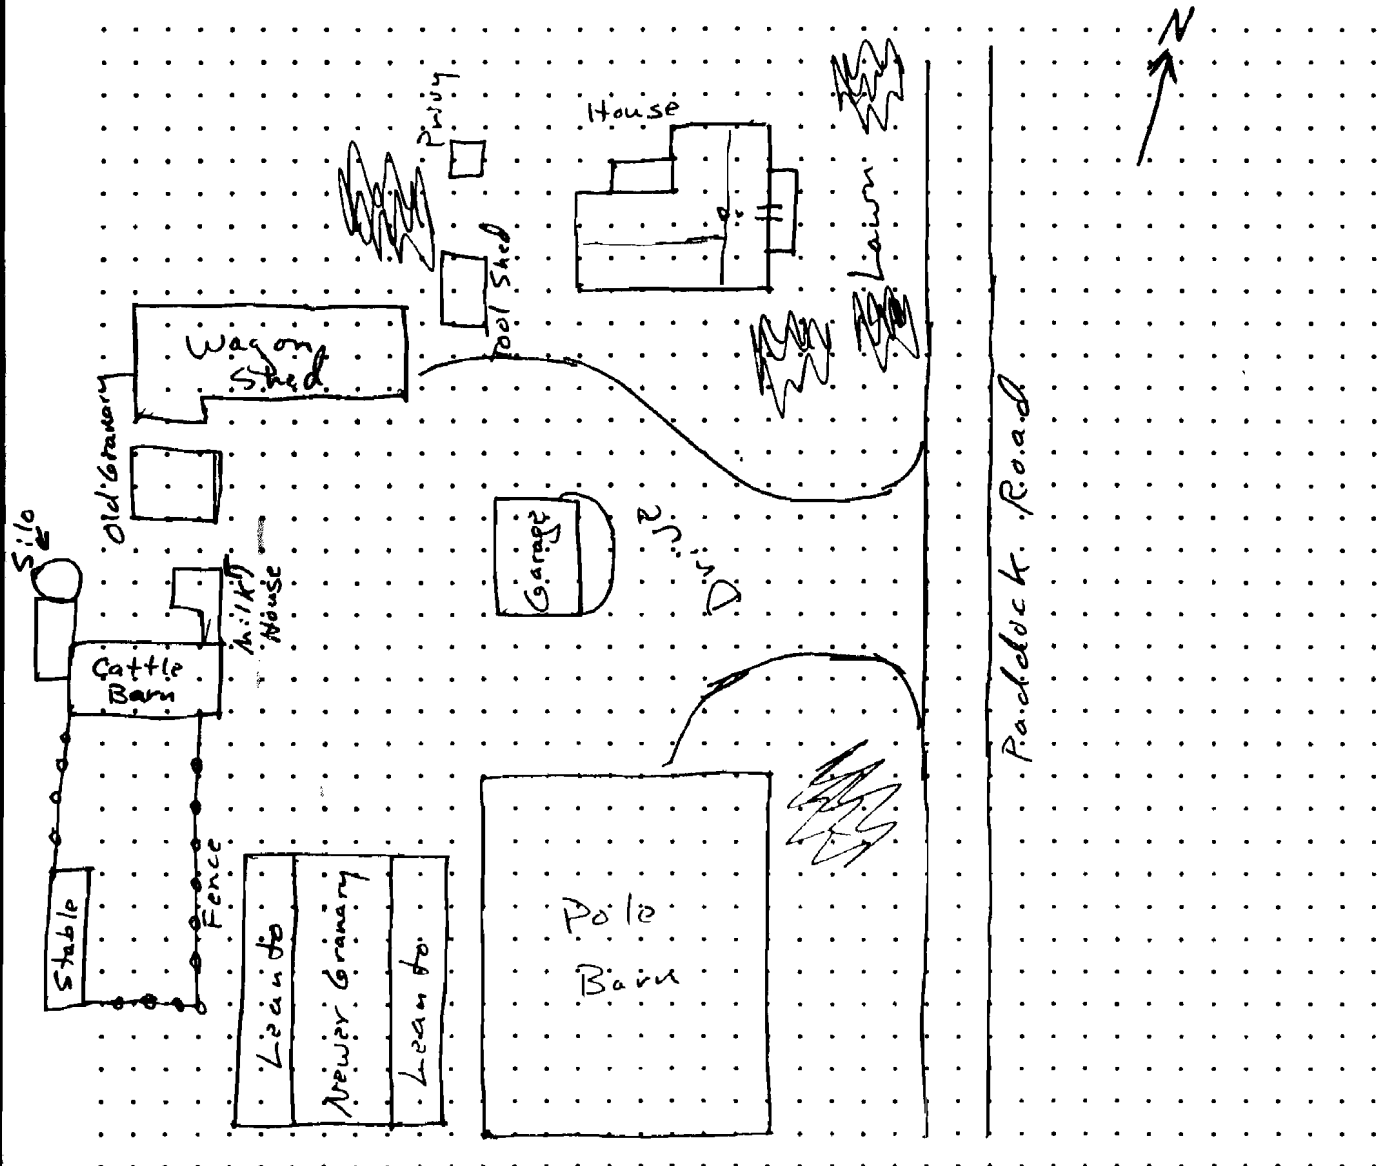
SKETCH MAP:

Show relationship to geographical landmarks and major features of environment.

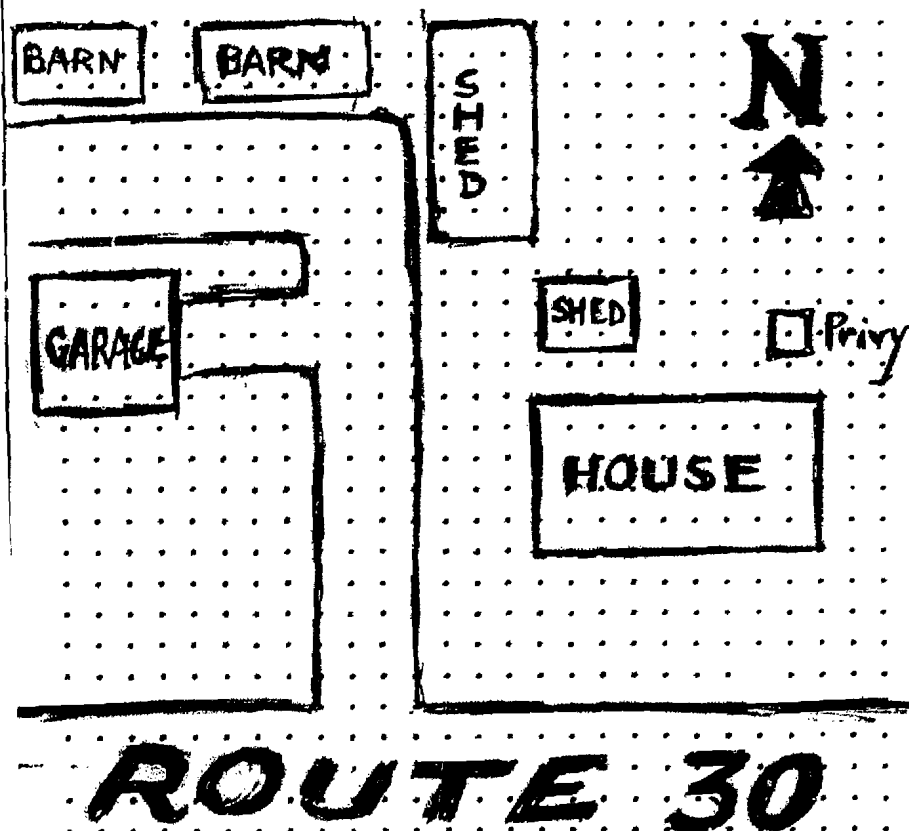
Residence is a farmhouse of a late ornate trim, probably late nineteenth century, victorian farmhouse cross-gable style. The gable cornice work (trim), the emphasis on the front door with its elaborate side lights and round-arched double doors, indicates a quality and prosperity of the farm at the time of its construction.

The residence is surrounded by farmland, but has a "proper" front lawn and trees to complete the setting. Outbuildings associated with the farmhouse surround the residence. (See the sketch to the left). Newer farm outbuildings reveal that the farm is still in operation and most likely still prosperous.

In comparison to other farmhouses in the area, this residence is of very high quality and is a good example of the vernacular farmhouse architecture of the area.

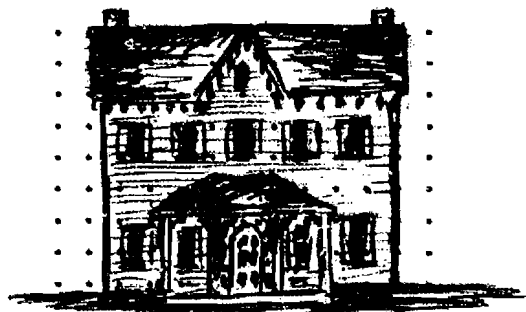
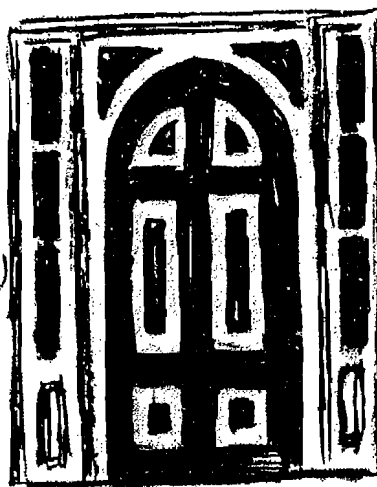
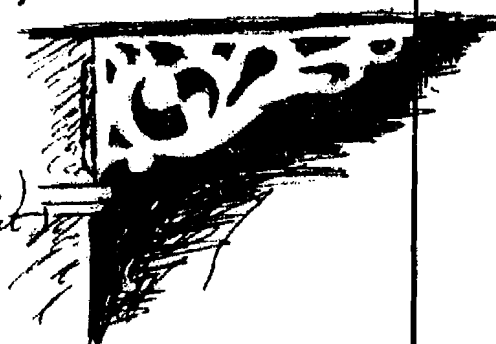
SKETCH PLAN

e) Roof shape: materials cross gable
Covered with tar shingles
cornice Boxed with ornate brackets (see sketch) above
dormers none
chimney location(s) two on each end of the gables (north and south ends)

g) Door spacing symmetrically - in center of facade
type ornate, 3 side light (see sketch) with panel below
trim very ornate, curved mouldings - COVED CORNICE

h) Porches open style
location(s) located at east front facade
materials wood squared posts
supports
trim very ornate scroll cut pieces (brackets) (see sketch to the right)
